# Manhole Inspection Summary

Manhole # S35SS1016MH

Insp Date: **2/28/07 10:10 AM**

**Location** Address: **421 TANTALLION CT**

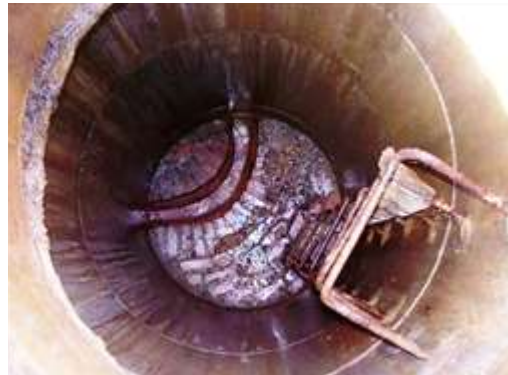
Top View

**Bench** ☒ Exists Material: **Brick** ☐ Parged ☒ **Debris** (not Condition related)

**Surcharge** ☒ **Evidence Of Surcharge** Depth: **1** (ft.) ☐ Active Surcharge Present

Evidence of surcharge - Bench debris.

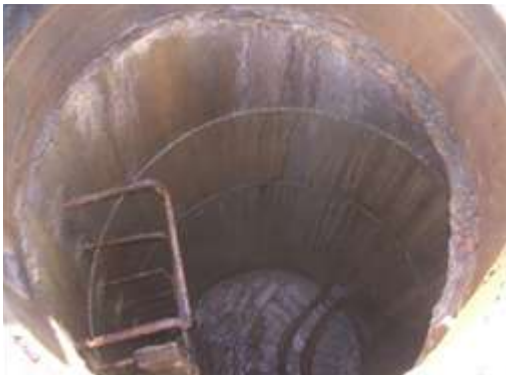
Defect

**Frame** Offset: **0** (in.) Condition: ☐ Sound ☐ Cracked ☒ **Leaks**

Condition: ☐ Sound ☐ Cracked ☐ Root Intrusion ☐ Loose Brick ☒ **Deteriorated**

Infiltration: ☐ None ☒ **Joint** ☐ Cracks ☐ Mortar ☐ Roots ☒ **Wall**

Frame leaks. Adjustment deterioration and infiltration - other side.

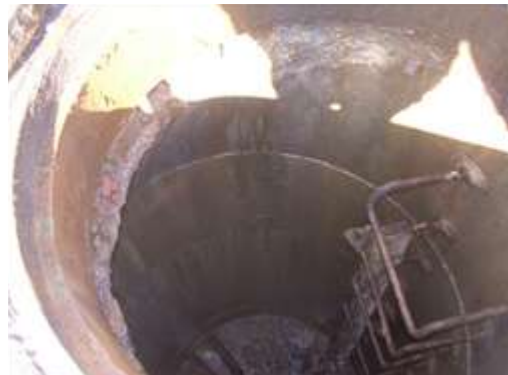
Defect

Frame leaks. Adjustment deterioration and infiltration.

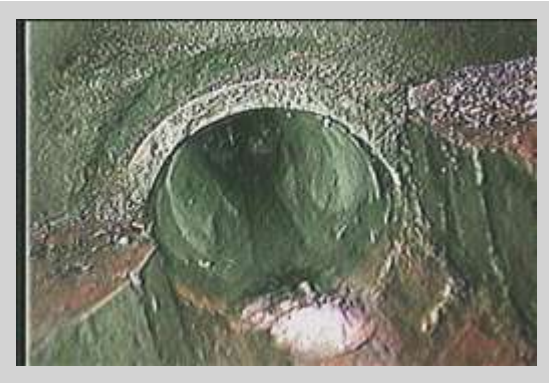
### 8 in. Circular Gravity Sewer Pipe Out @ 12 O'Clock

Deposits: ☐ None ☐ Mud ☐ Sludge ☒ Debris ☐ Grease

Silt Depth: **0** (in.) Deposits Extent: **Light**
